Cost estimates for Glen Osmond Creek minor upgrade works

# COST ADVICE

## GLEN OSMOND CREEK

### Torrens Ave and Fern Ave - Bridge Upgrade

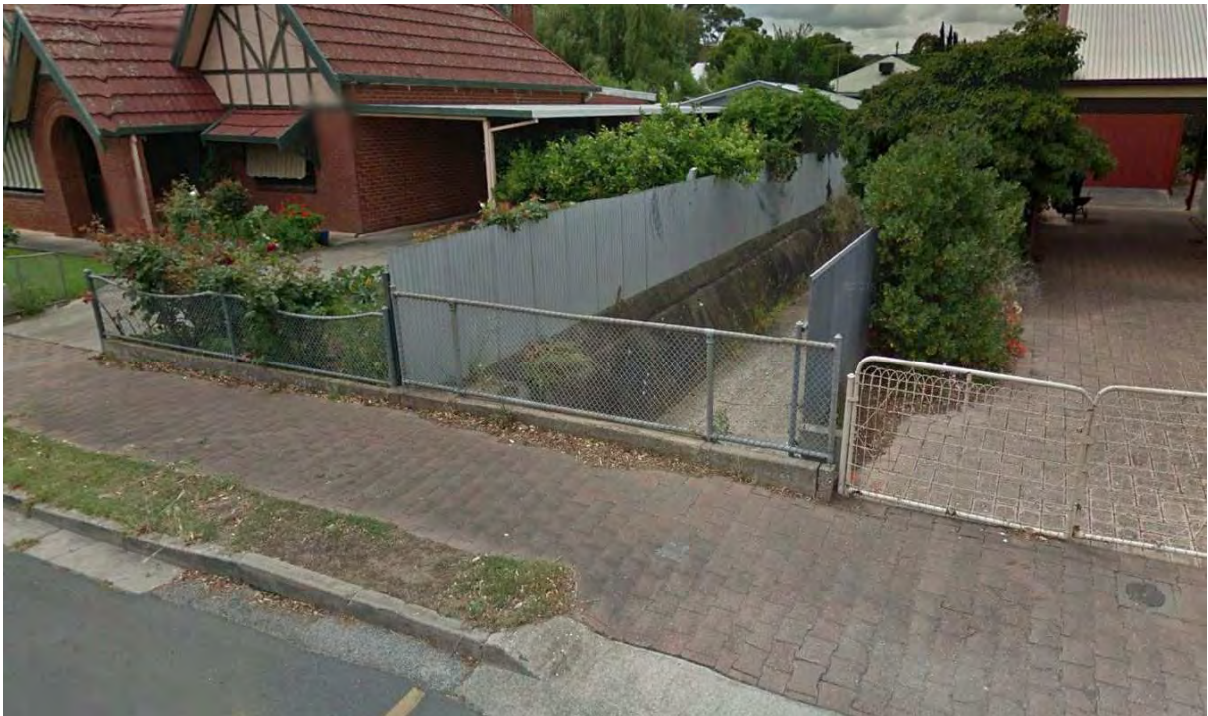
Photo 1: View of Eastern Side of the Torrens Avenue Culvert

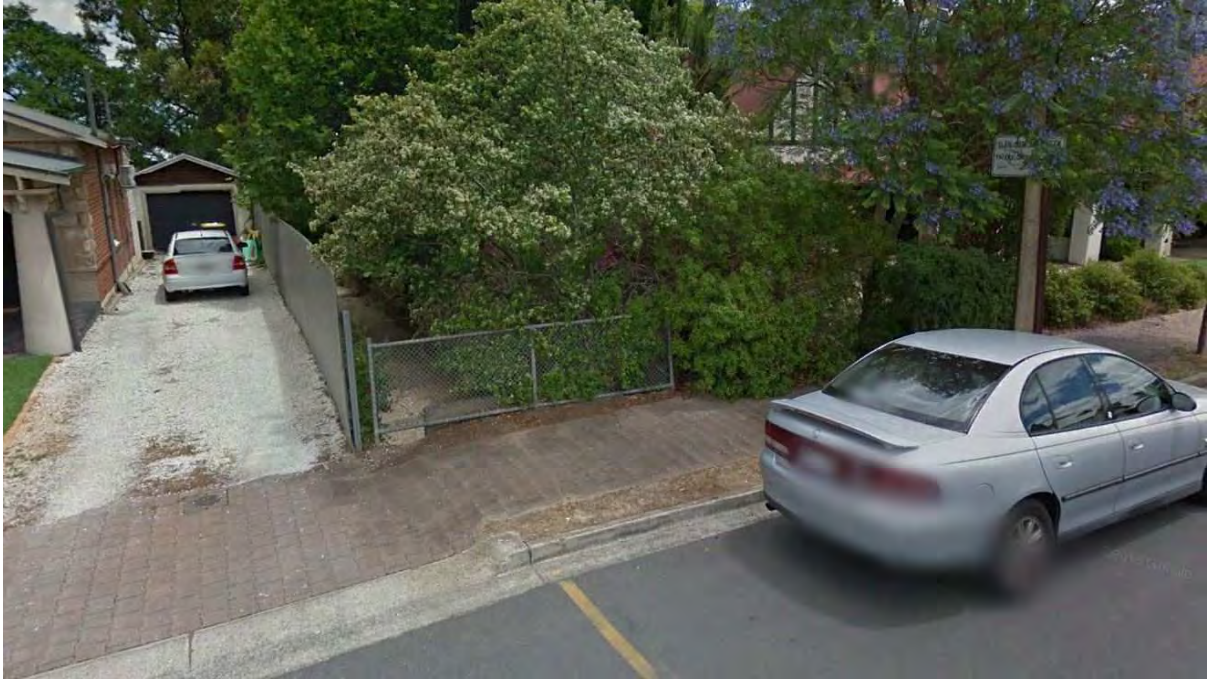
Photo 2: View of Western Side of the Torrens Avenue Culvert

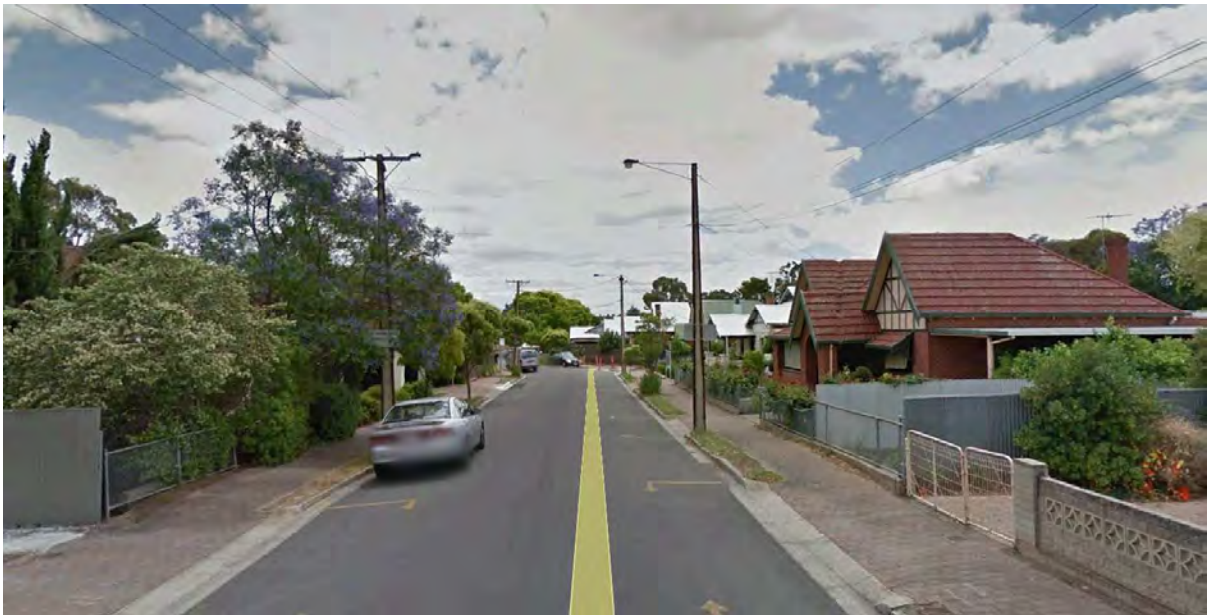
Photo 3: View of Torrens Ave Culvert Crossing

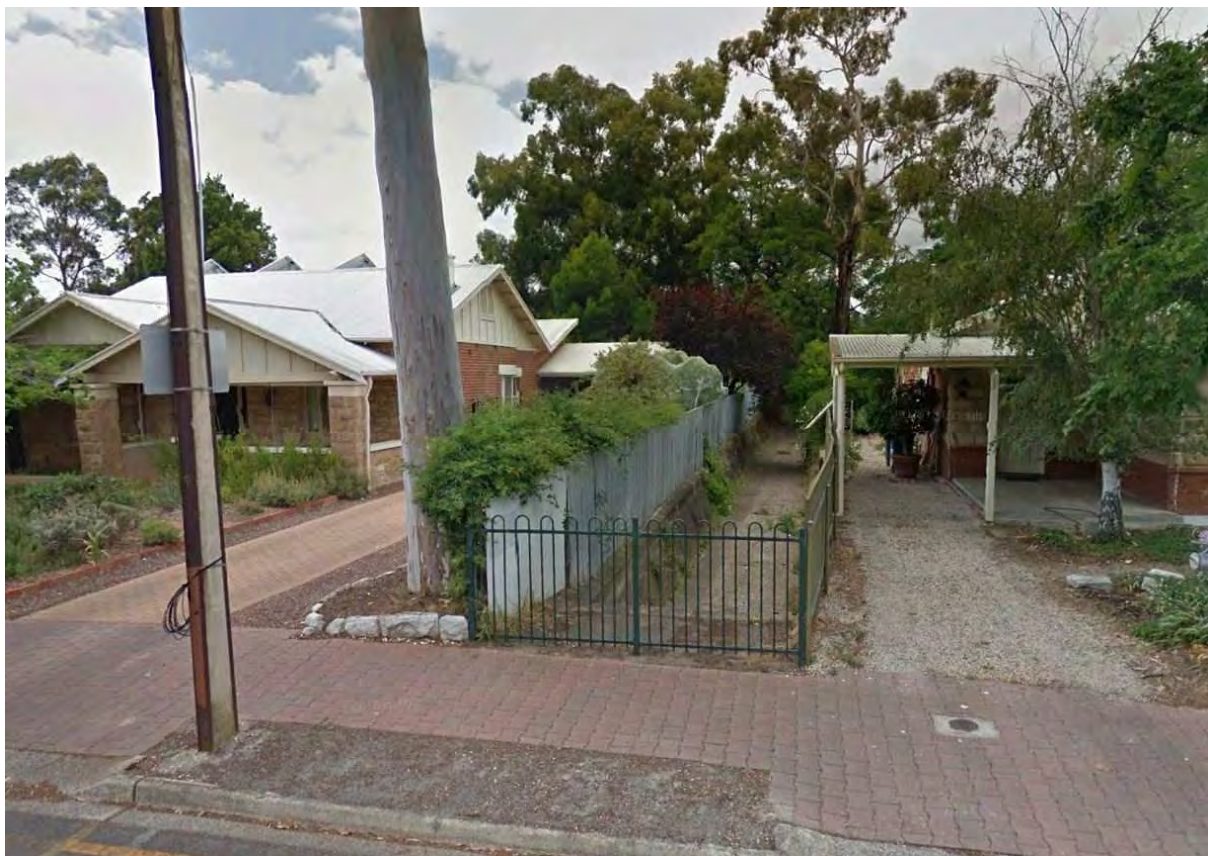
Photo 1: View of Eastern Side of the Fern Avenue Culvert

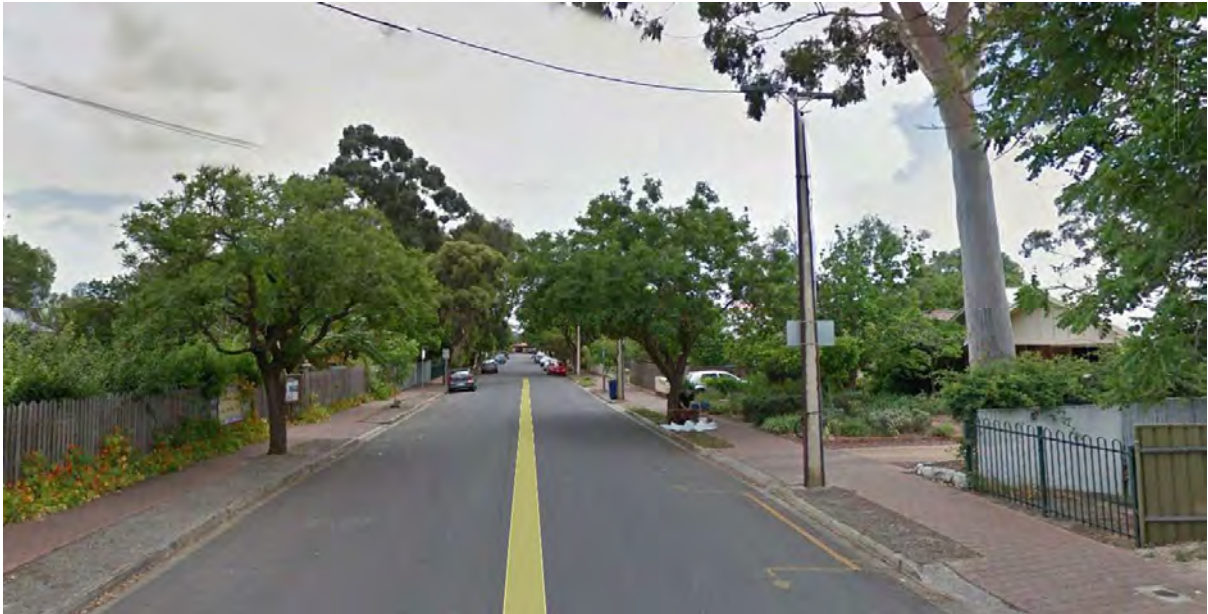
Photo 2: View of the Fern Avenue Culvert Crossing

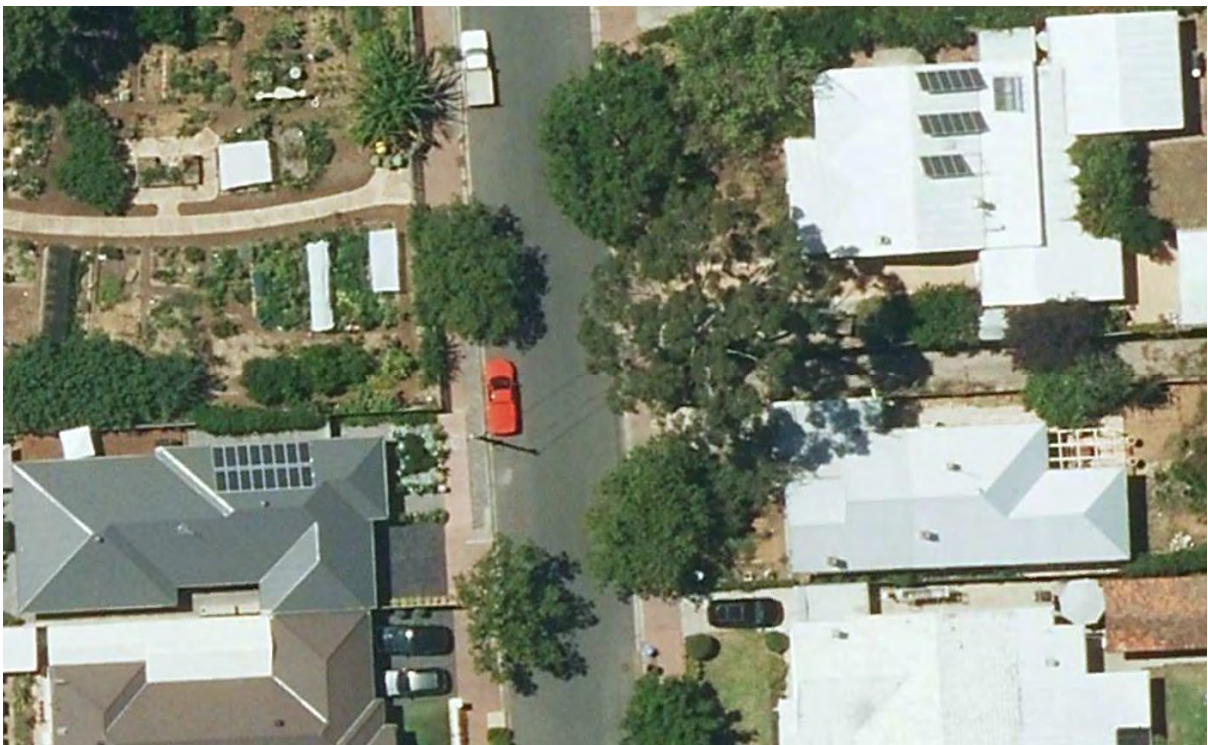
Photo 3: Aerial View of the Fern Avenue Culvert Crossing Location

Note: the culvert appears to be underground through the gardens on the Western side of the road.

- Refer photo 3: The culvert appears to extend underground from the Eastern side of Fern Street. The scope of this estimate is limited to the road crossing.
- In the brief the length of the culvert is listed as 6m. However the estimate has allowed for a full road width replacement.
